Navajo Abandoned Uranium Mine

Site Screen Report

Tony Tuc AUM Site

August 2010

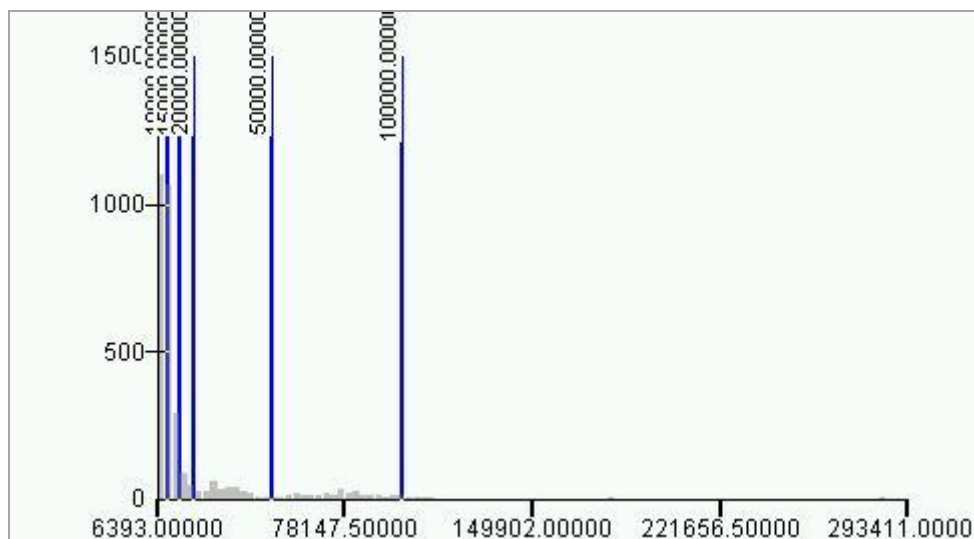
The following chart and statistics were generated by ESRI ArcGIS 9.3.1, and show the general distribution of the site gamma radiation measurements. The horizontal X axis represents the gamma radiation reading levels in cpm (lowest levels to the left). The vertical Y axis represents the frequency of each gamma radiation level.

Count:	3214
Minimum:	6393.00000
Maximum:	293411.00000
Sum:	68603868.00000
Mean:	21345.32296
Median:	10177.50000
Standard Deviation:	31416.67066

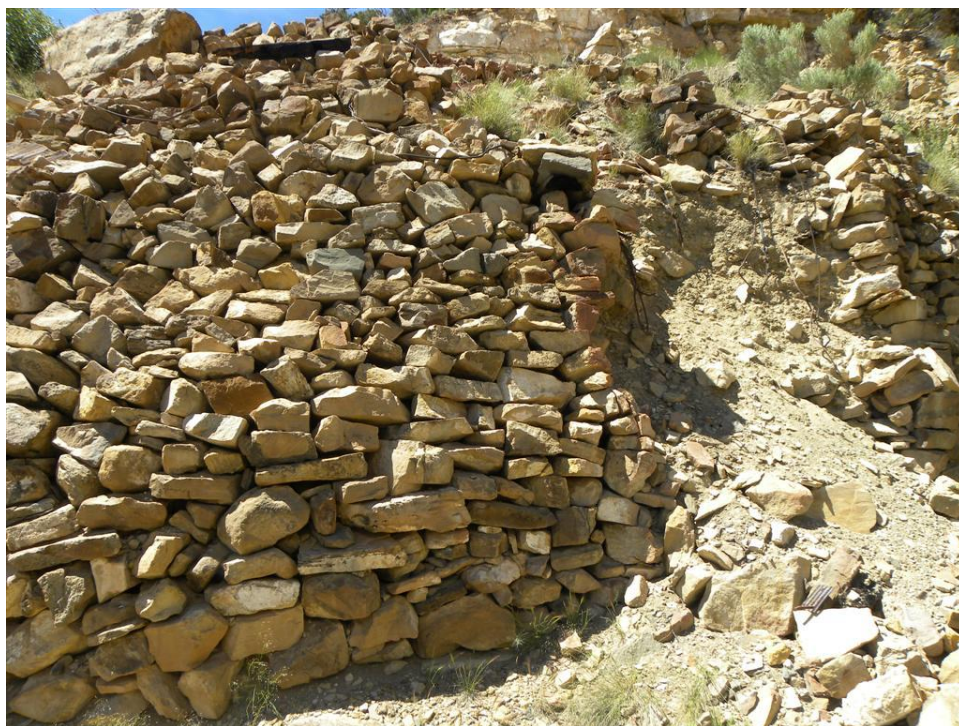
Large stone sealed adit, 30'x20' with various metal debris around base

Photo 3. Tony Tuc site, sealed adit

Sealed adit; unreclaimed waste piles

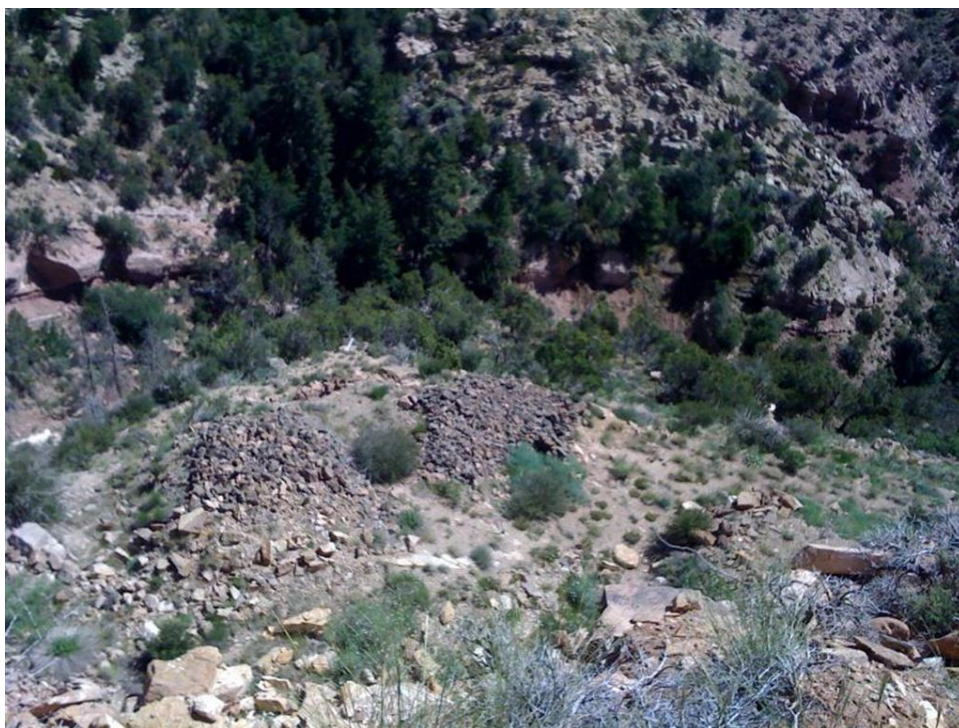
2 waste piles side by side above adit; dark grey rocks, 15'x15'x3'; small dark grey rock 5'x5'x3' pile below adit; scattered dark grey rocks along haul road

Photo 4. Tony Tuc site, waste piles

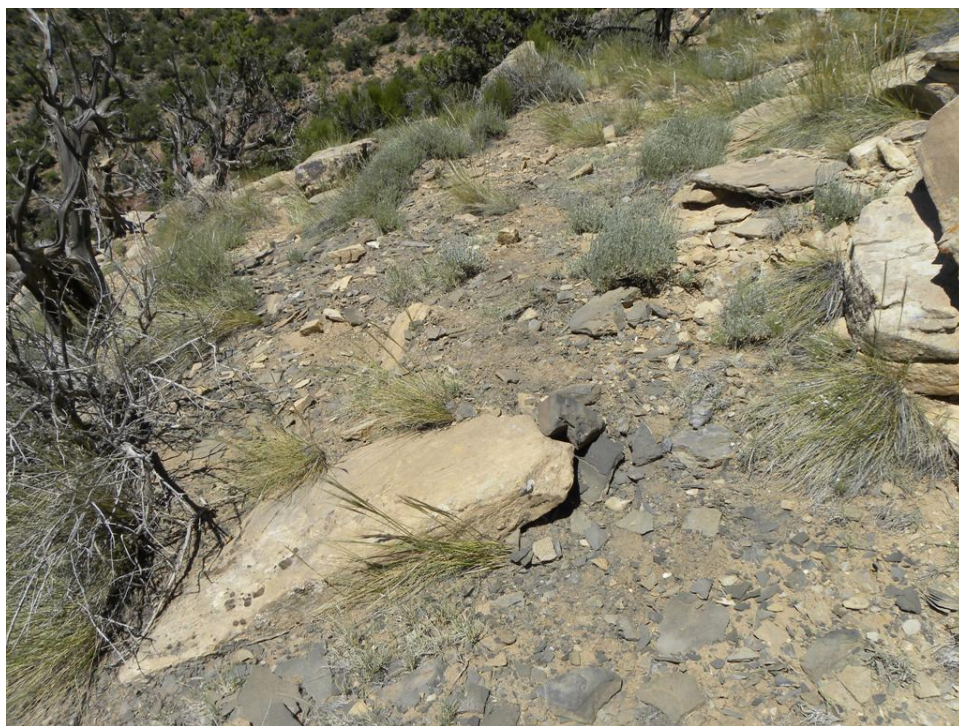
Photo 5. Tony Tuc site, scattered waste rock

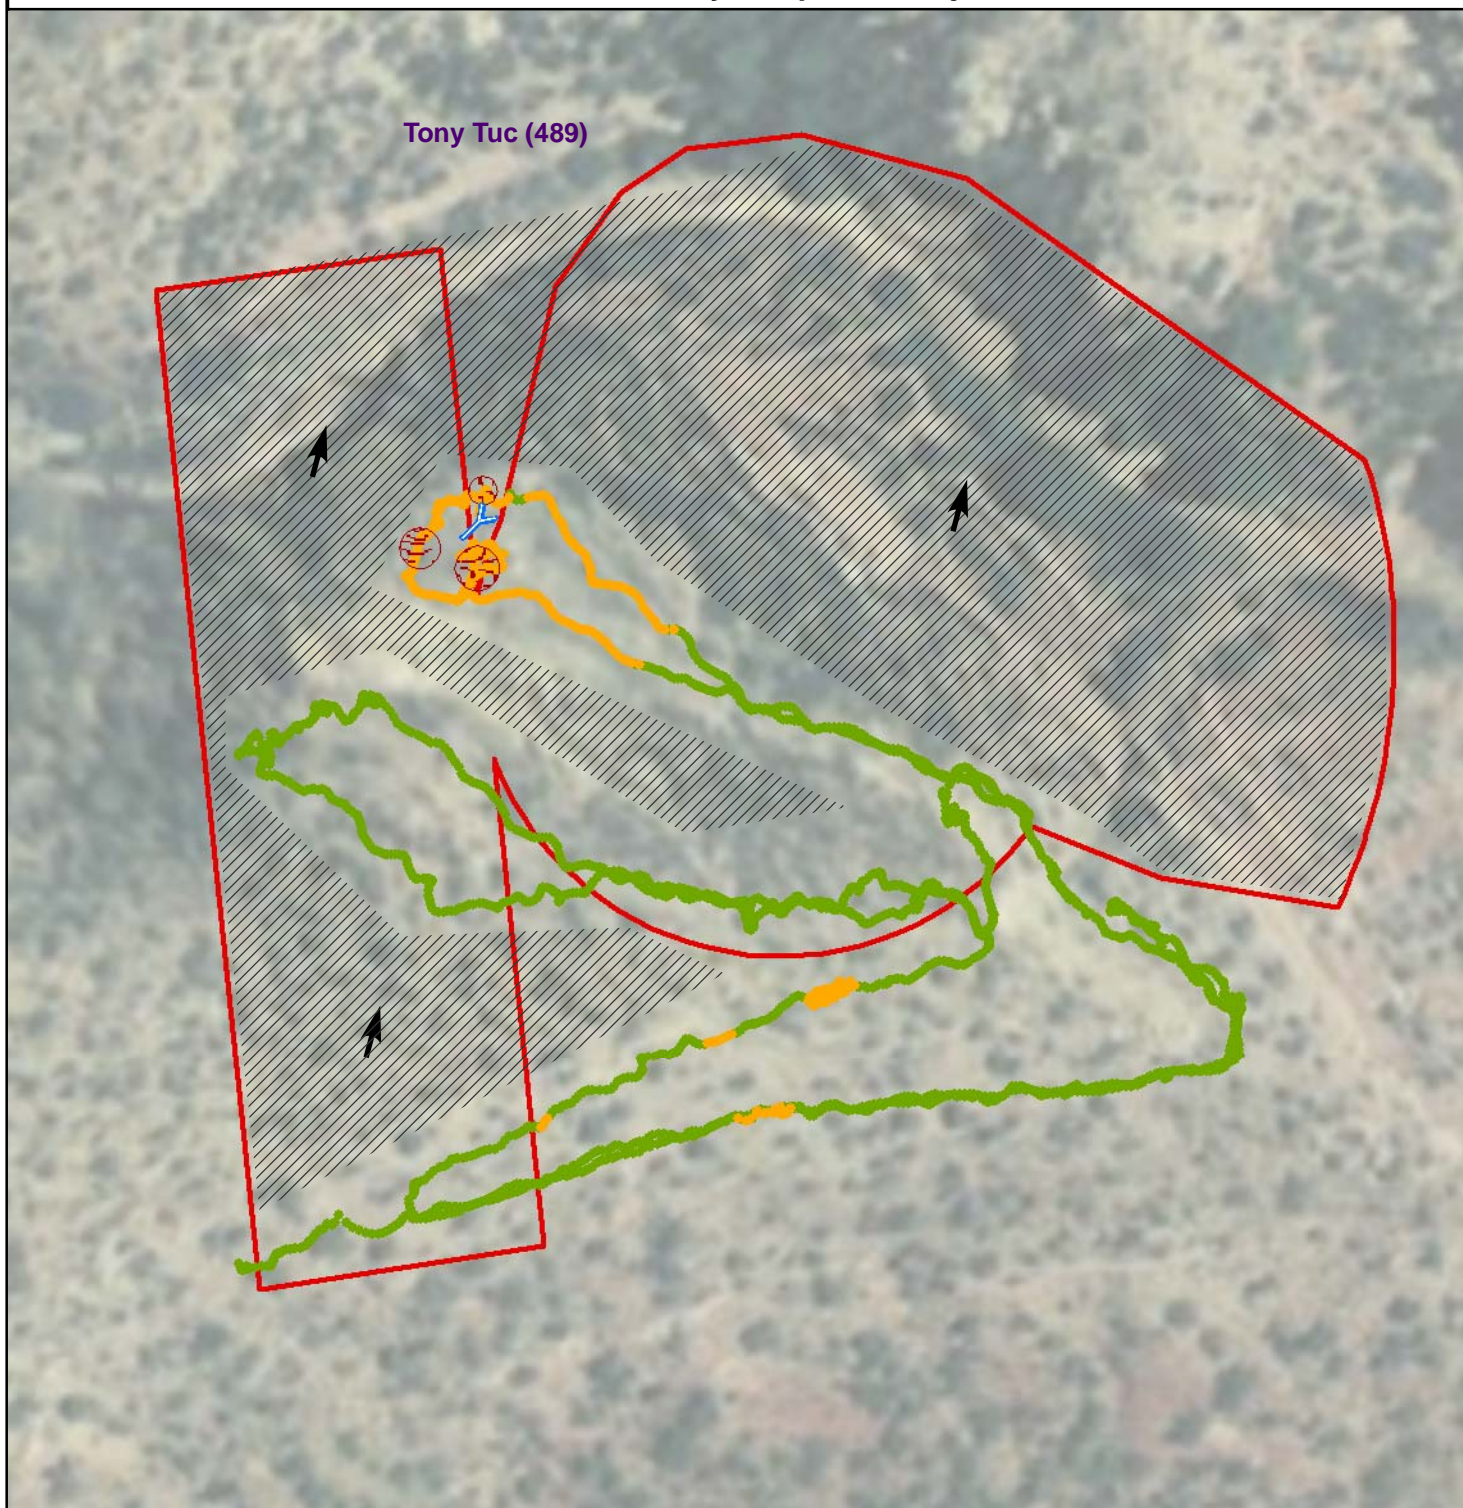
A total of 3,214 gamma radiation measurements were collected from the mine site, ranging from 6,393 cpm to 293,411 cpm. Measurements collected in the vicinity of the waste debris above the adit were found at levels up to approximately 125,000 cpm, below the adit at levels up to approximately 300,000 cpm, at scattered debris along the road at 200,000 cpm, and at the adit at 40,000 cpm. The measurements are represented in Figures 1 and 2.

**Figure 1 - Gamma Radiation Measurements, Above Two Times Background
Tony Tuc (489)
Beclabito / Red Valley Chapter, Navajo Nation**

Gamma survey conducted 06/2010
Measured as counts per minute (cpm)

Average background = 9,026 cpm

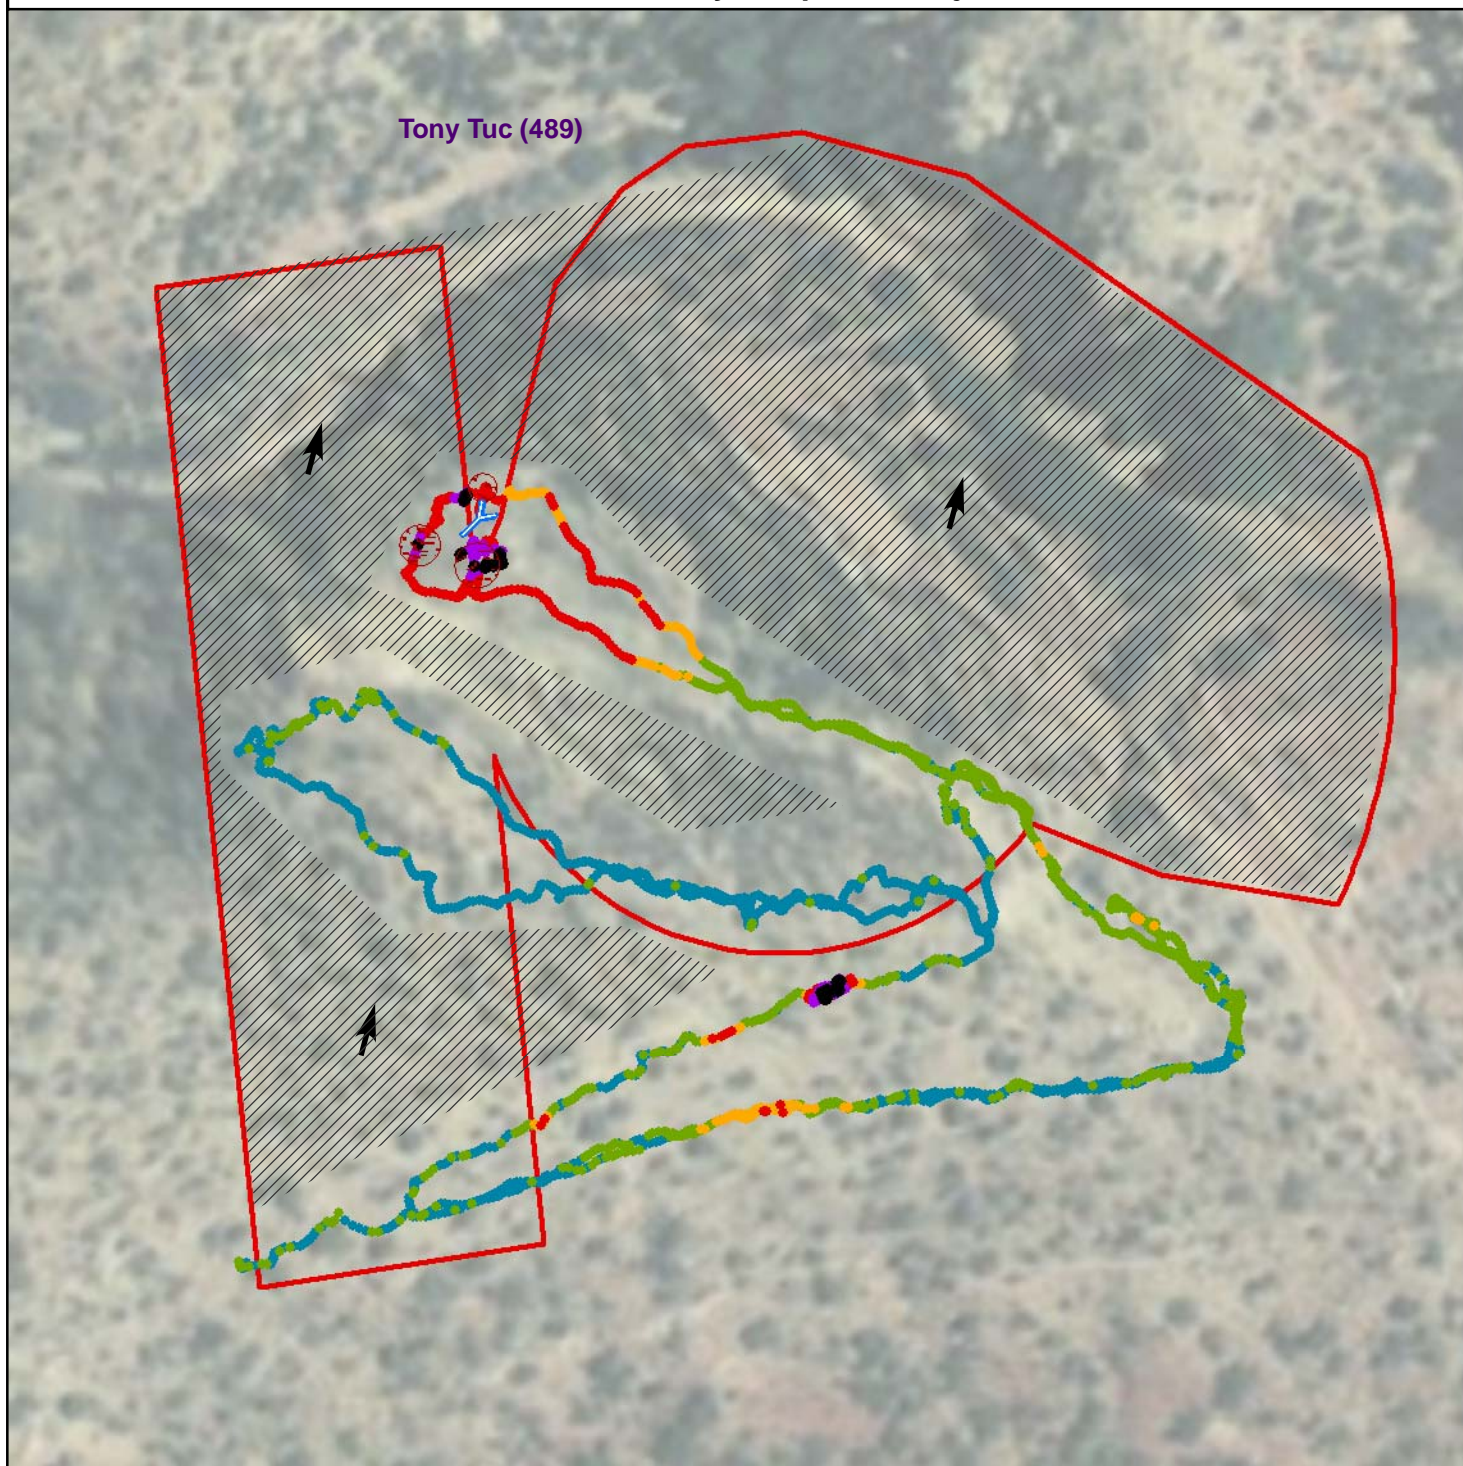
Figure 2 - Gamma Radiation Measurements
Tony Tuc (489)
Beclabito / Red Valley Chapter, Navajo Nation

Gamma survey conducted 06/2010
 Measured as counts per minute (cpm)

Average background 9,026 cpm
